FOREST PRODUCTS RESEARCH IN PICTURES

NO. 69

CREOSOTED FLOOR LAID
IN DECAY HAUNT

FOREST PRODUCTS LABORATORY
U. S. FOREST SERVICE
MADISON, WISCONSIN

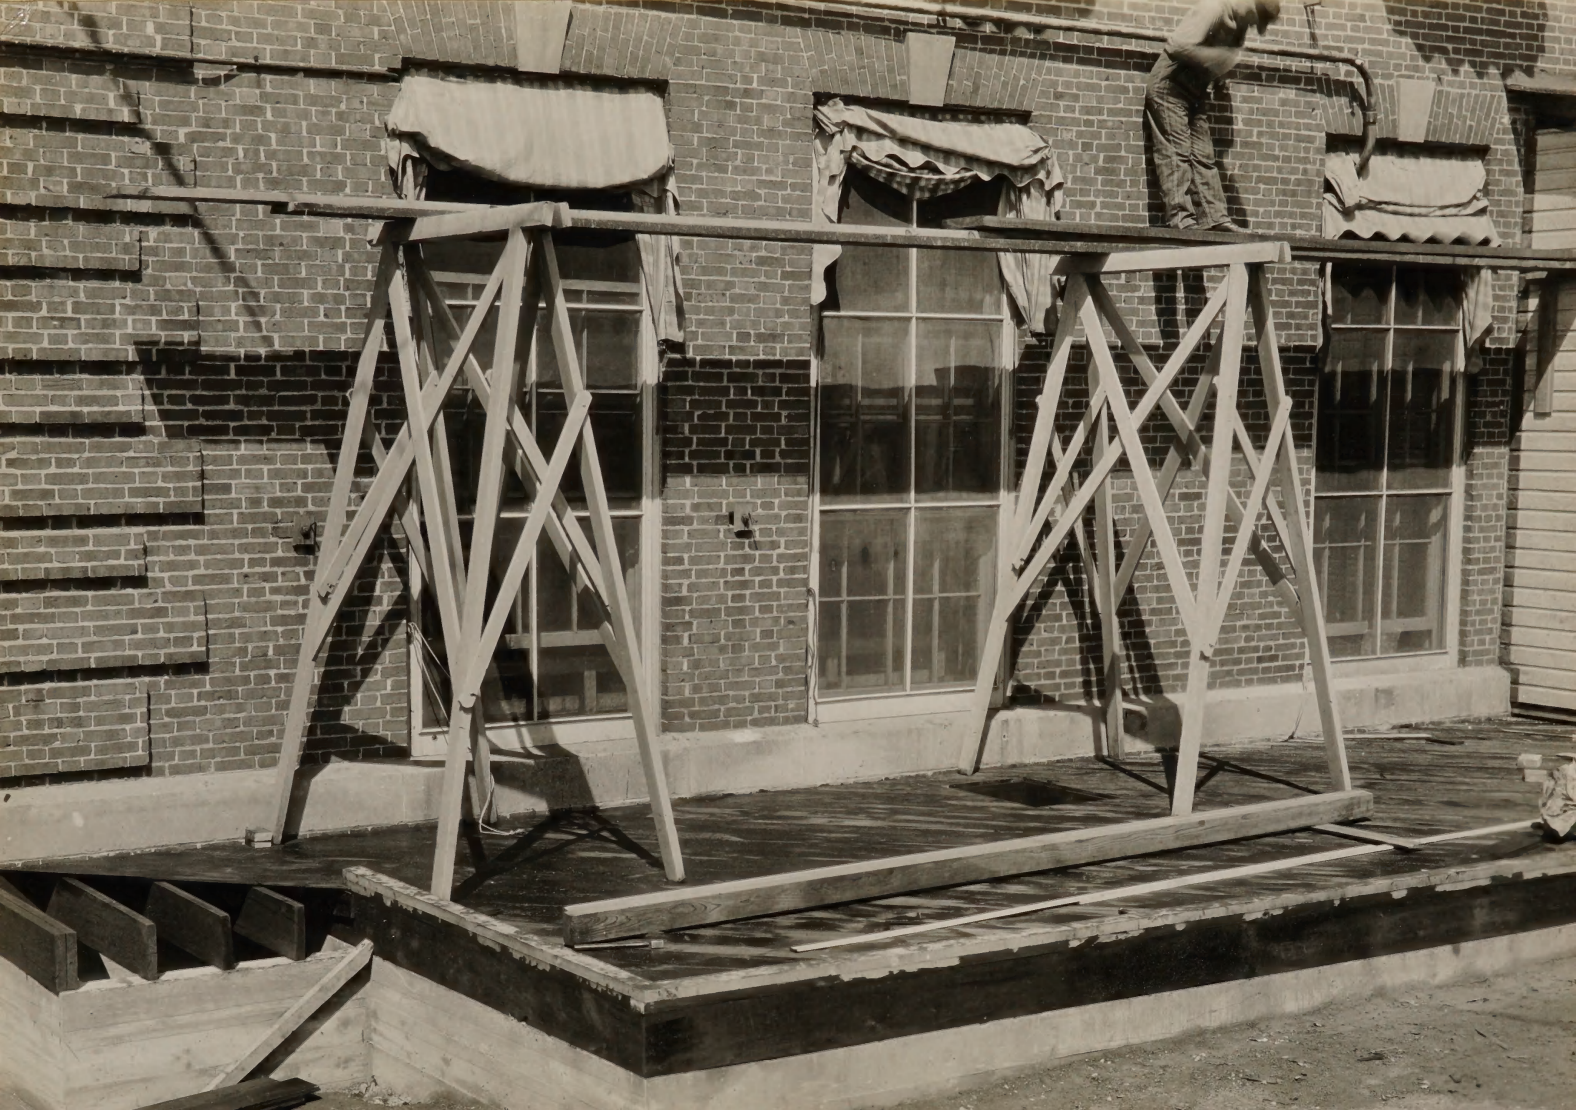
It is not infrequently true that "the cobbler's children have no shoes" and that the doctor will have none of his own medicine. But the creosoted subfloor shown here was treated and installed at the Forest Products Laboratory, one of the agencies urging the use of treated wood wherever it is feasible.

The foundation was low and there was no opportunity for ventilation beneath the floor. Because the conditions seemed to favor decay all joists and subfloor boards were pressure-creosoted. The subfloor boards were so well impregnated that it was not necessary to brush-treat the ends which were cut. As the joists were not cut to length before treatment these members were lap-jointed on a concrete foundation in the center to avoid cutting into untreated wood.

The Forest Products Laboratory believes that for long service in decay-favoring locations it is economical to use treated material, and that eventually it will be practicable to carry treated boards and timbers in stock in retail lumber yards.
